PPS - Wilson High School – South Bleacher Assessment

ABHT Project #11516

June 29, 2016

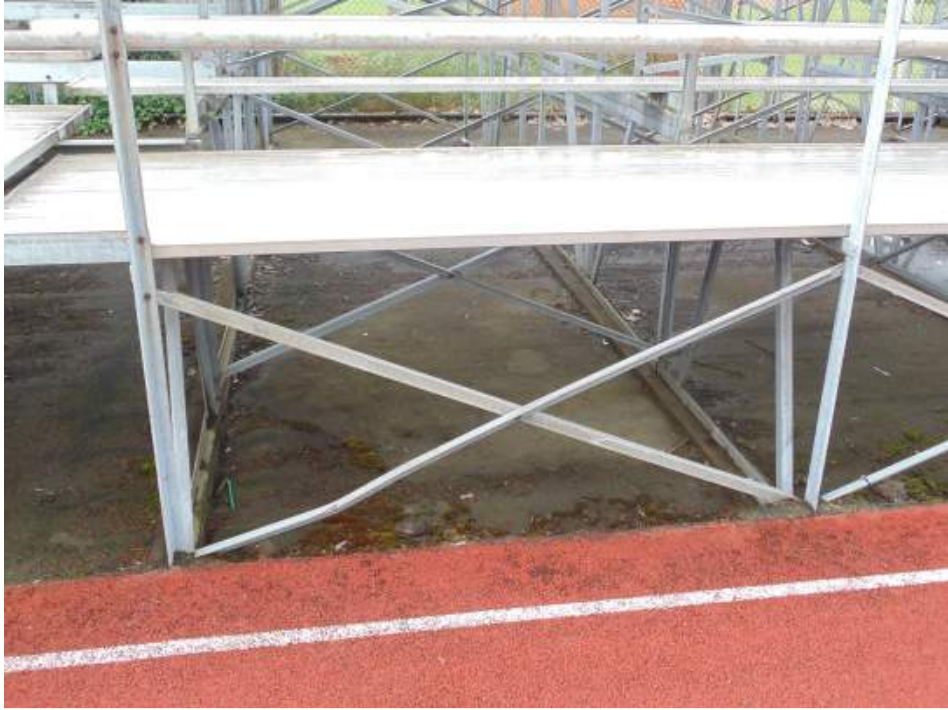
FIGURE S1: BENT CROSS FRAME ANGLE

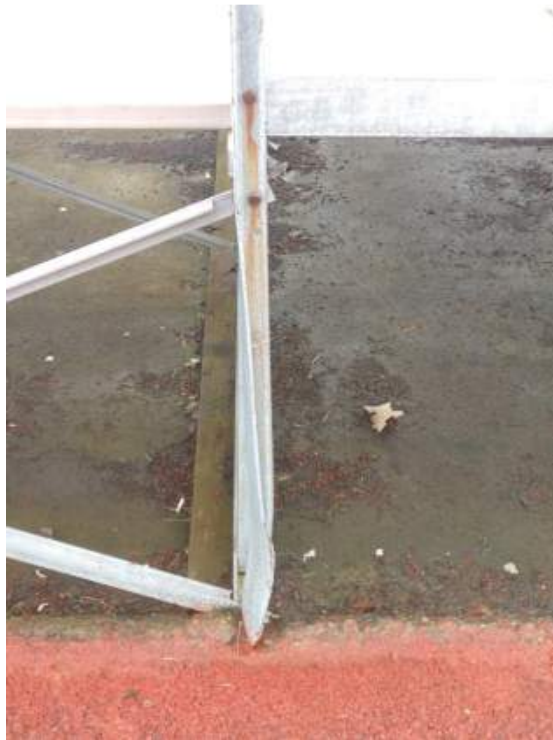
FIGURE S2A: BENT ANGLE

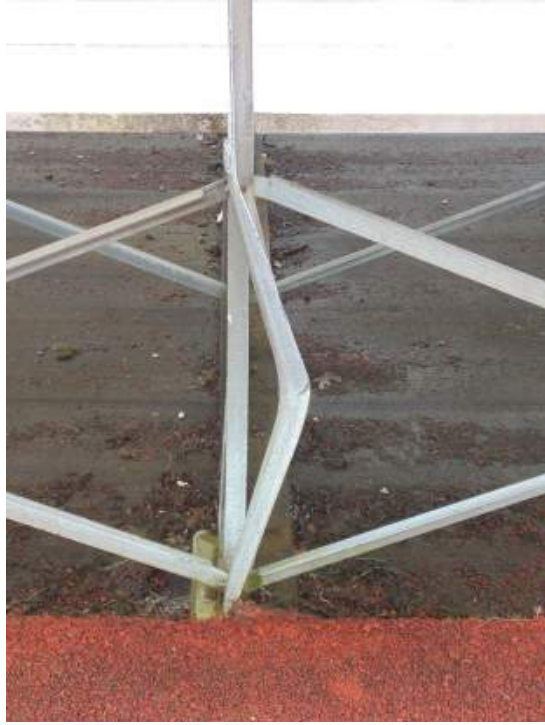
FIGURE S2B: BENT ANGLE

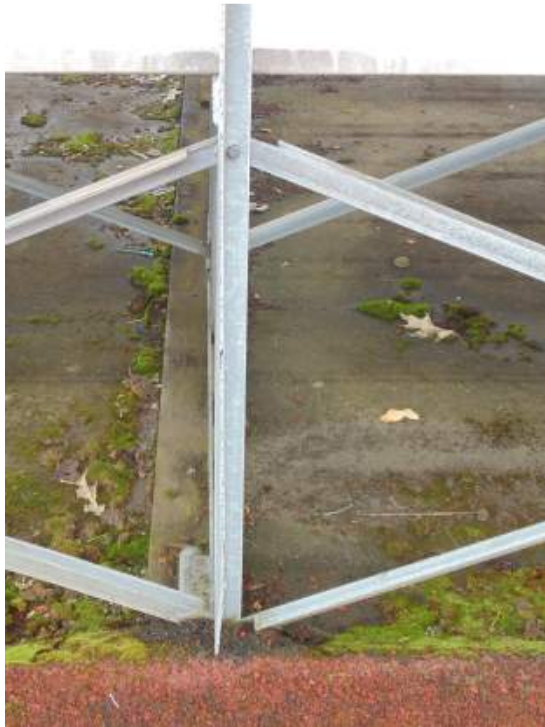
FIGURE S3A: DENTED ANGLE

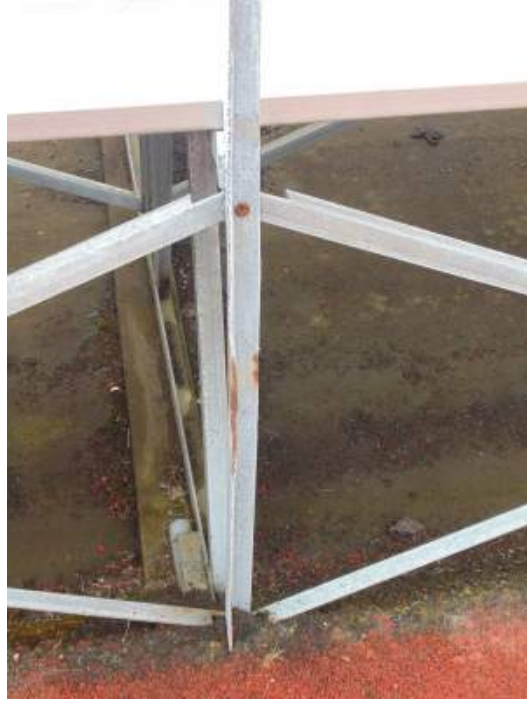
FIGURE S3B: DENTED ANGLE

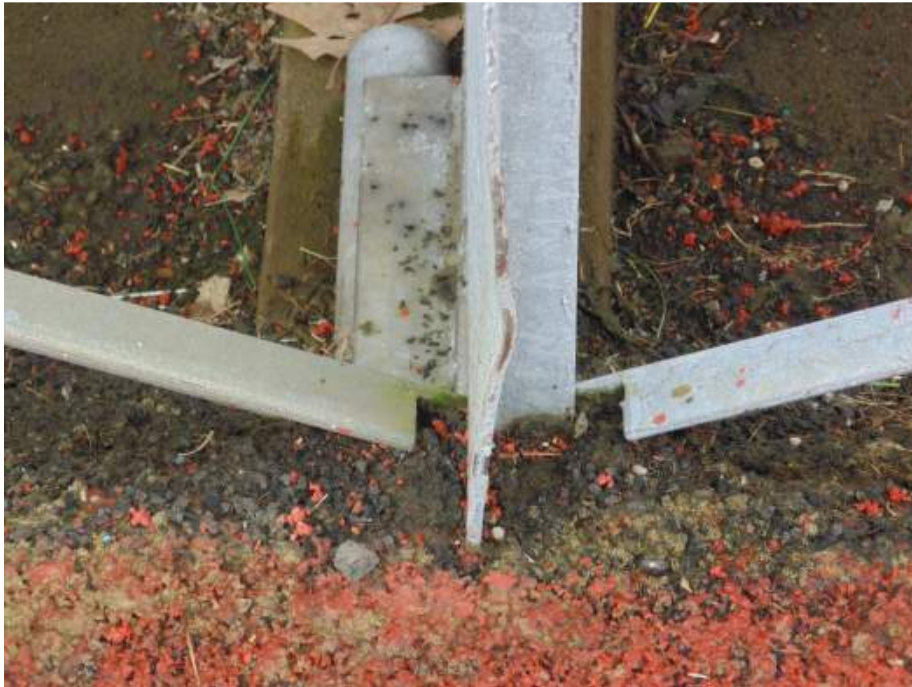
FIGURE S3C: DENTED ANGLE

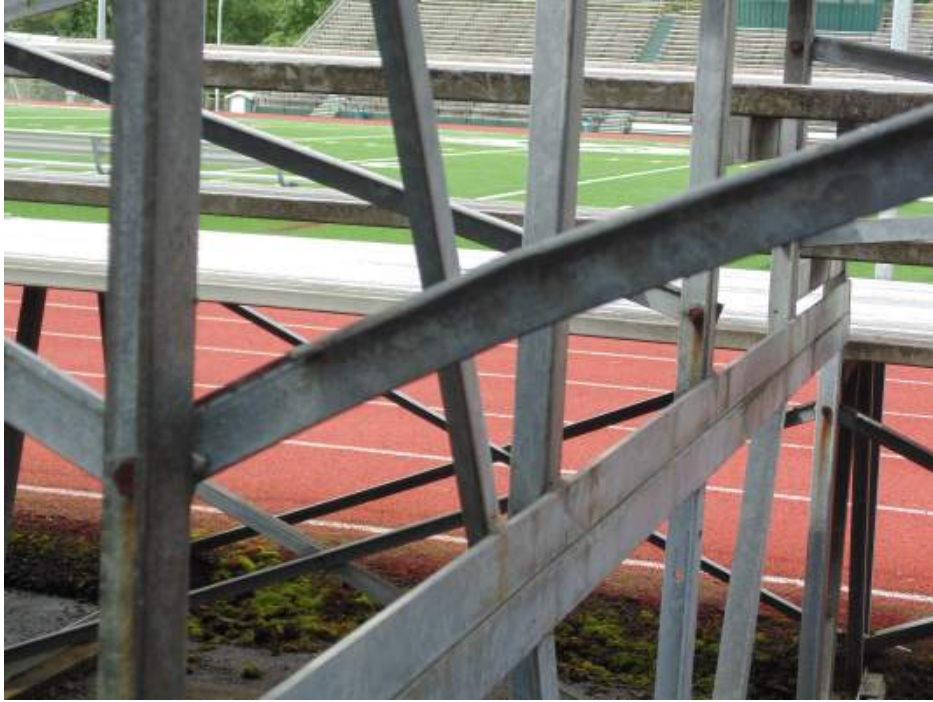
FIGURE S4: BENT ANGLE

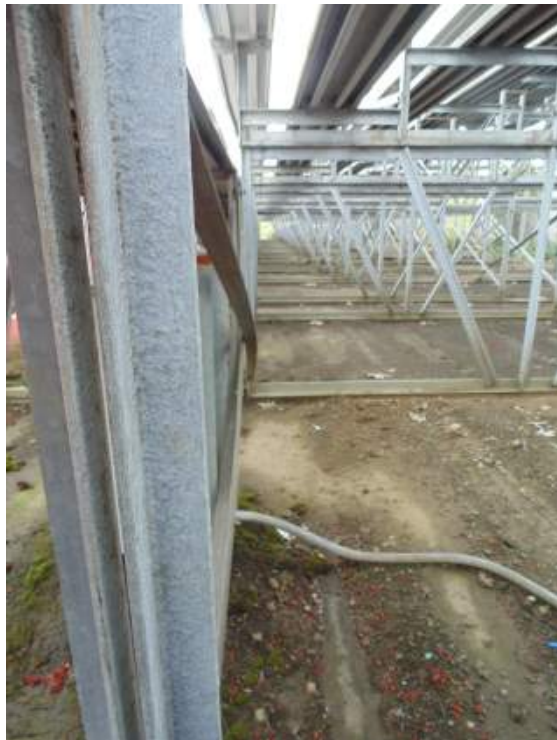
FIGURE S5: WARPED ANGLE

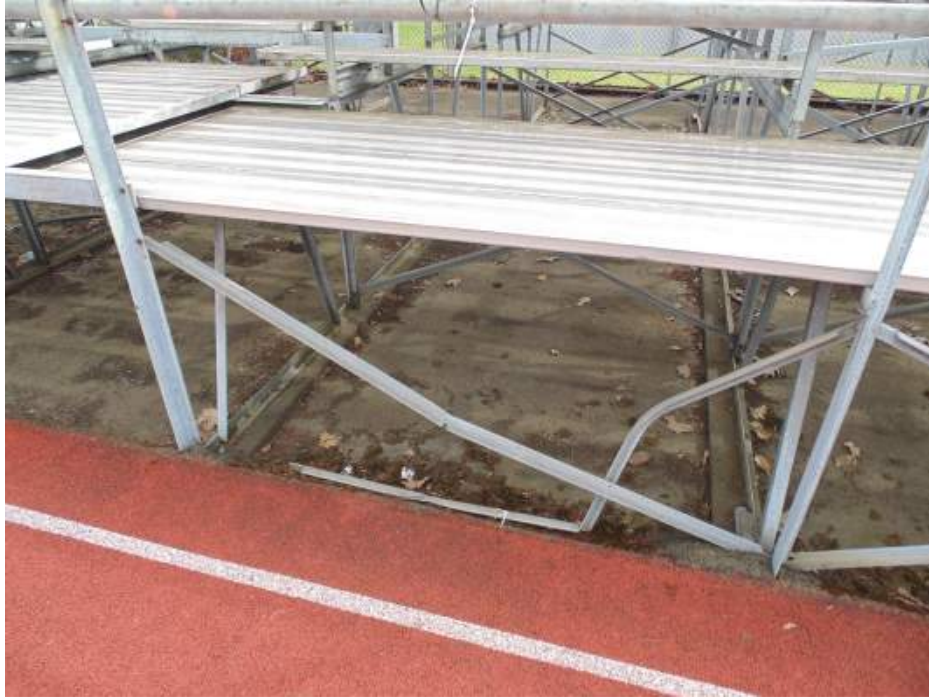
FIGURE S6: DESTROYED CROSS BRACE ANGLE

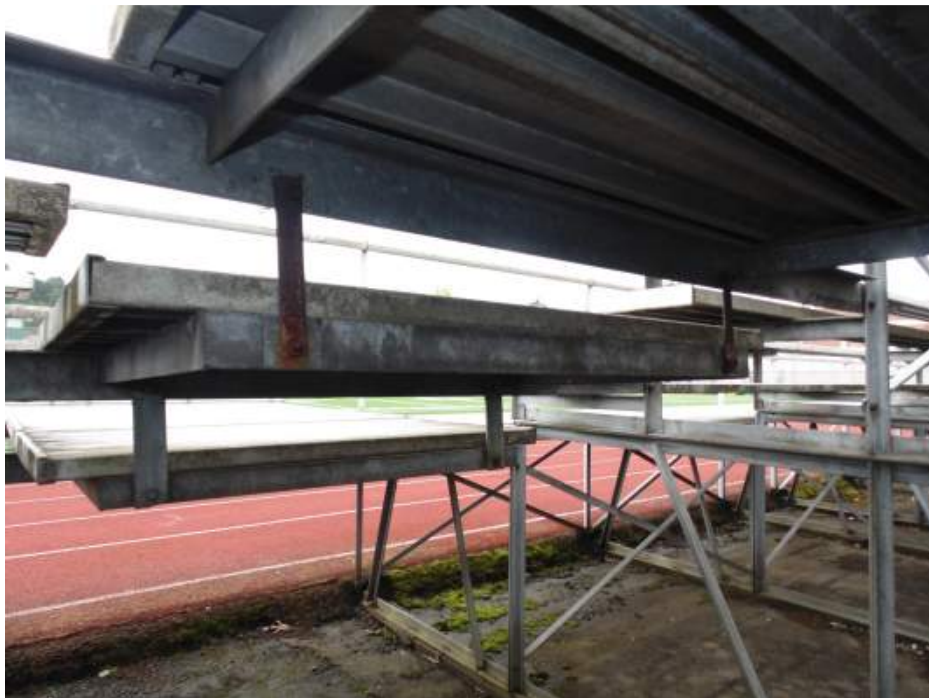
FIGURE S7: RUSTED PLATES AT STAIRS

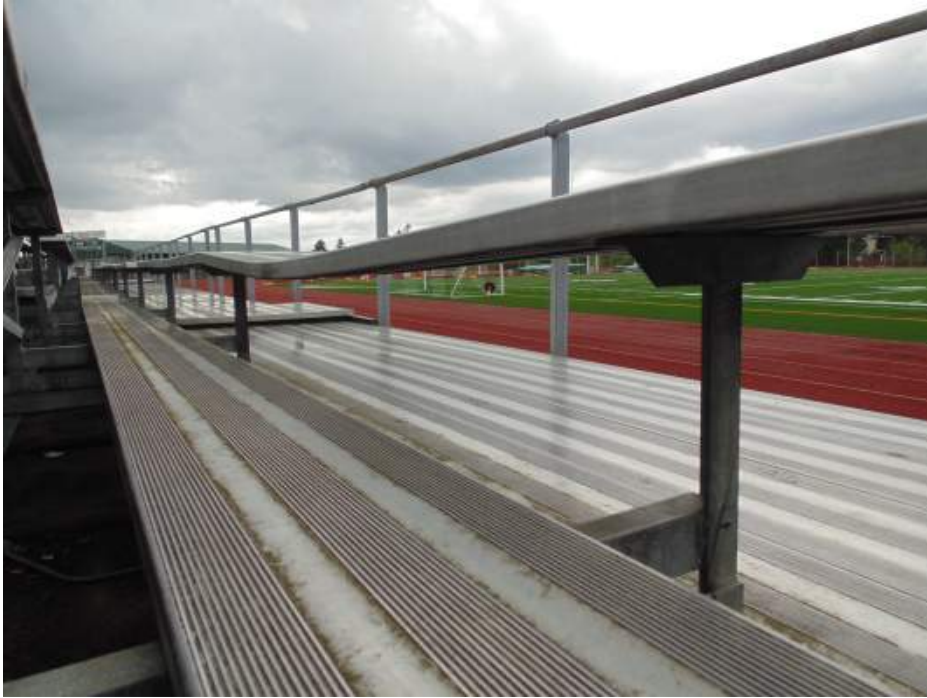
FIGURE S8: DAMAGED SEAT

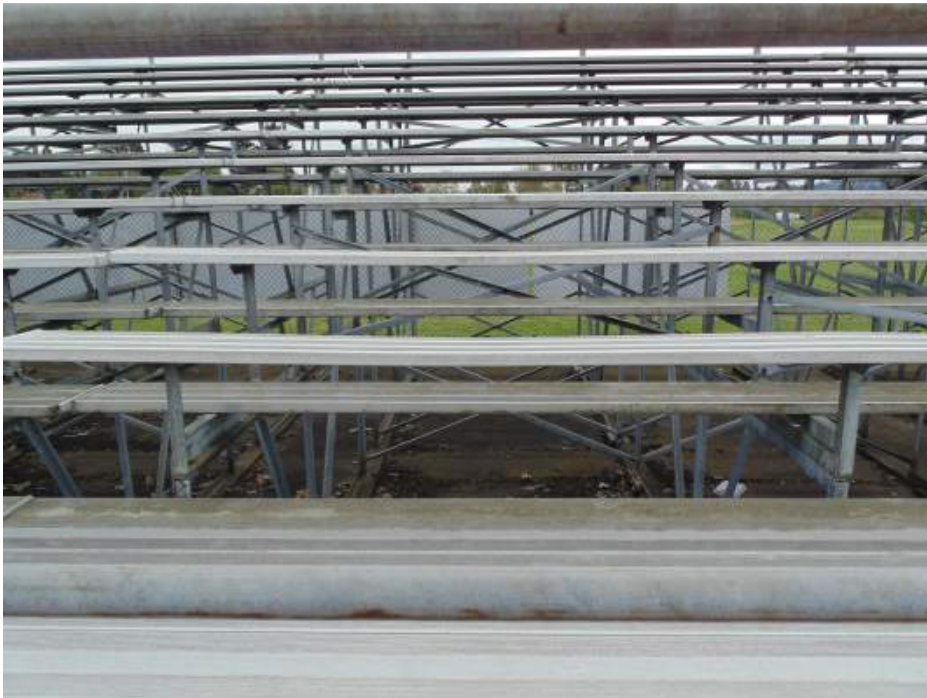
FIGURE S9: TYP. MINOR BENDING IN SEATS

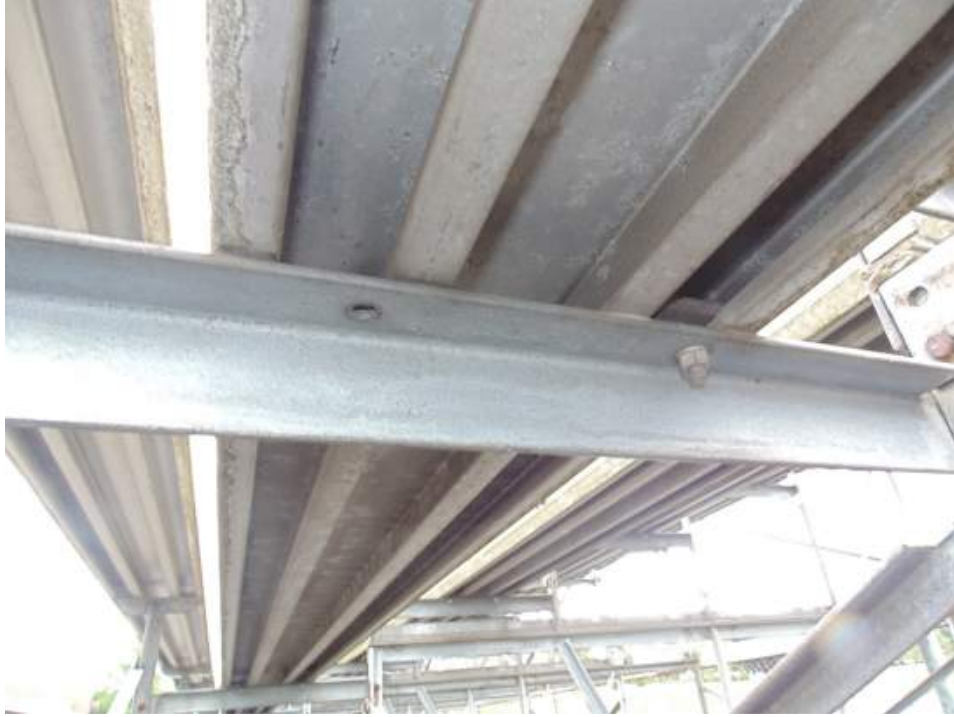
FIGURE B1: BOLT MISSING FOR SEAT/TREAD CONNECTION

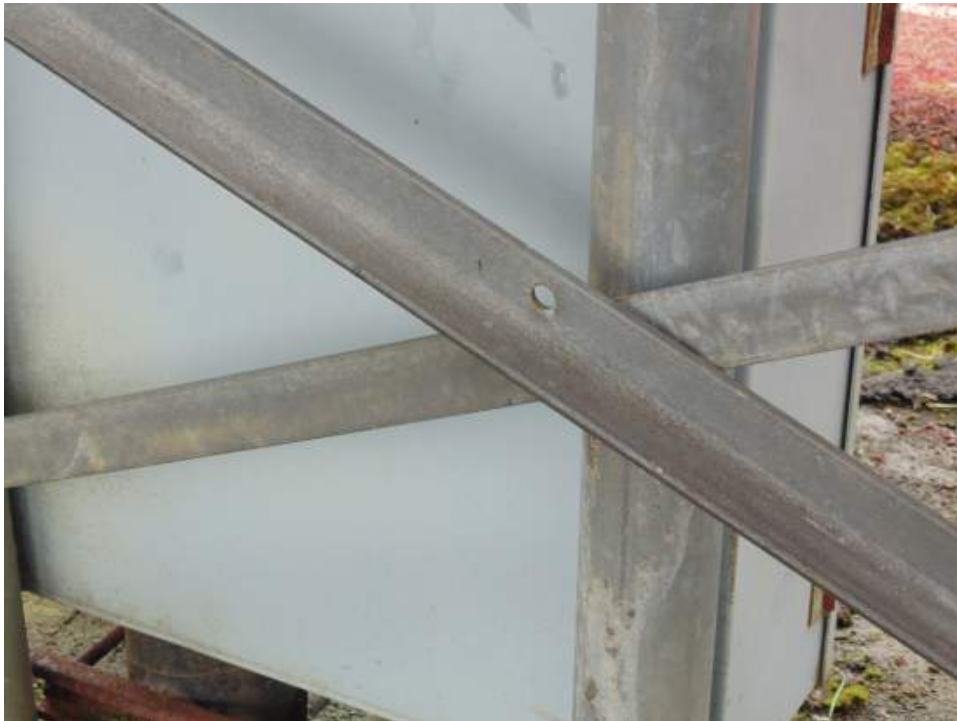
FIGURE B2: BOLT MISSING FOR BRACE CONNECTION

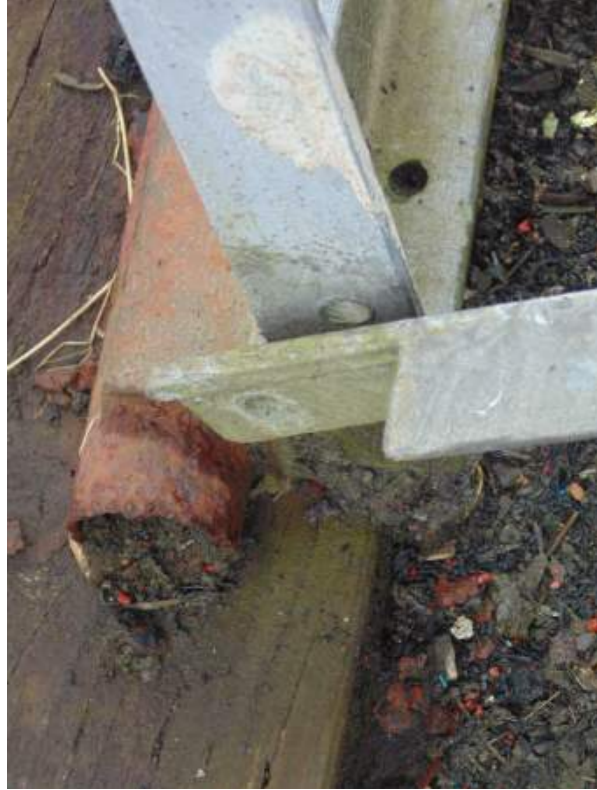
FIGURE B3: BOLT MISSING FOR FRAME TO FRAME CONNECTION

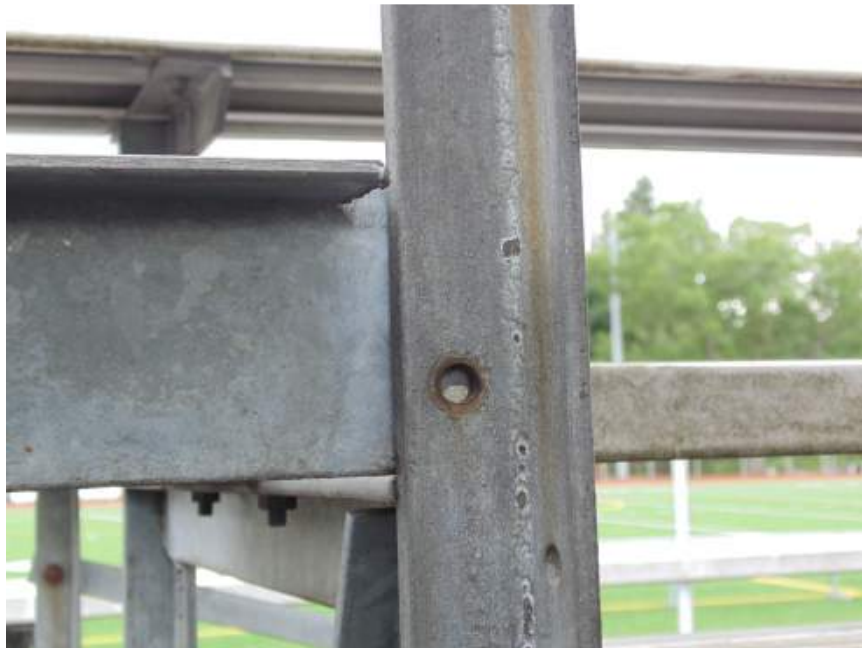
FIGURE B4: BOLT MISSING FOR STAIR ANGLE CONNECTION

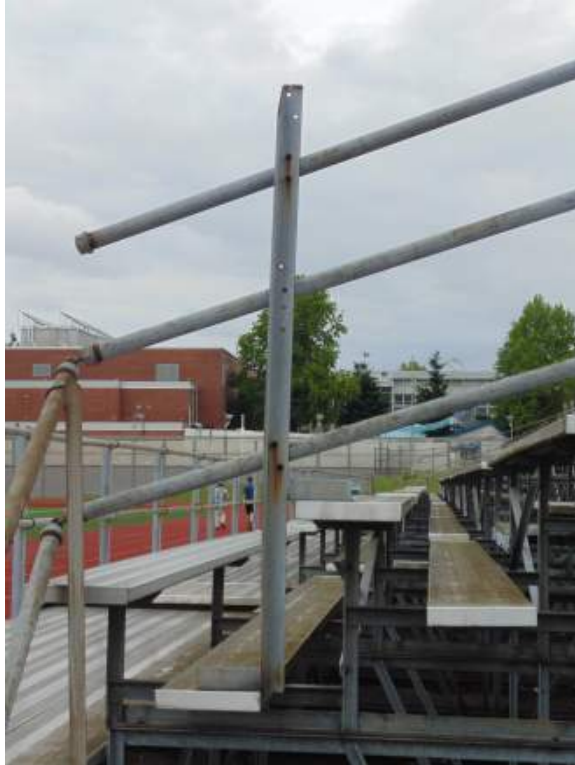
FIGURE B5: U-BOLT MISSING FOR RAILING CONNECTION

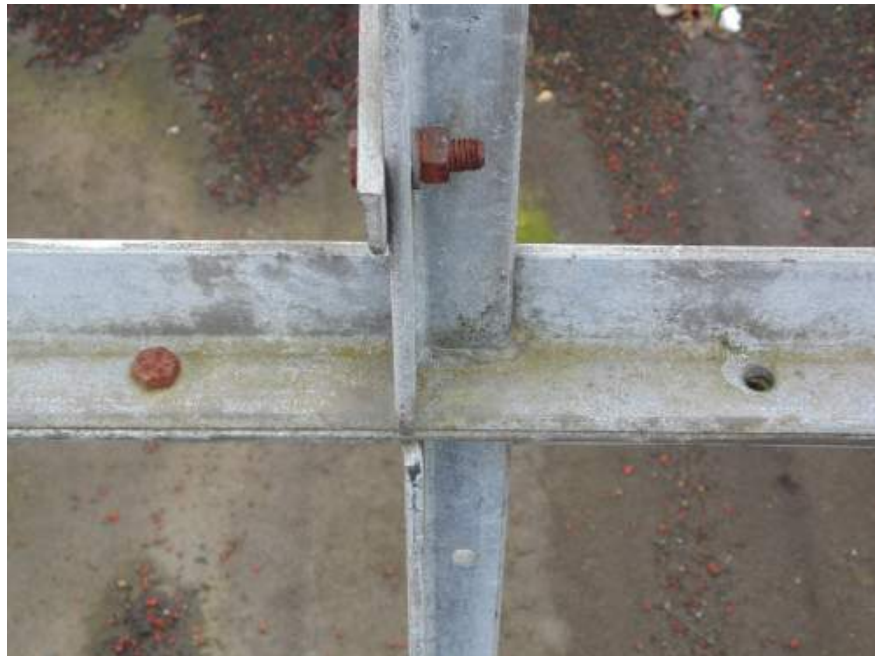
FIGURE B6: RUSTED SCREWS

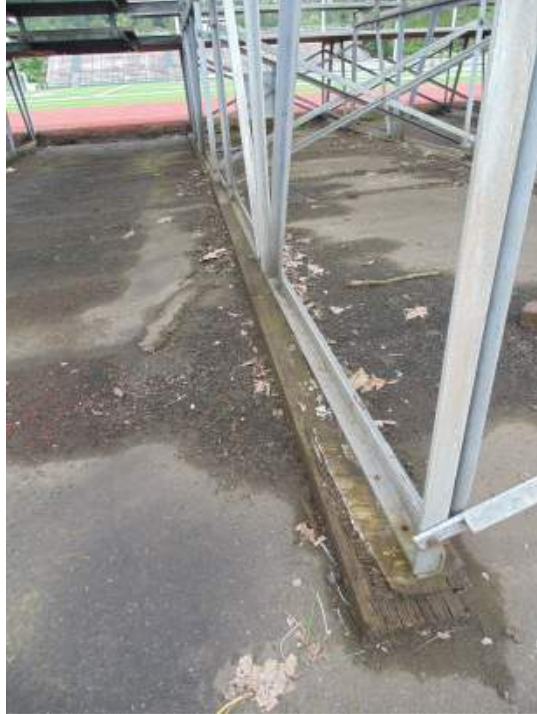
FIGURE W1: SUPPORTING WOOD MEMBER DETERIORATING

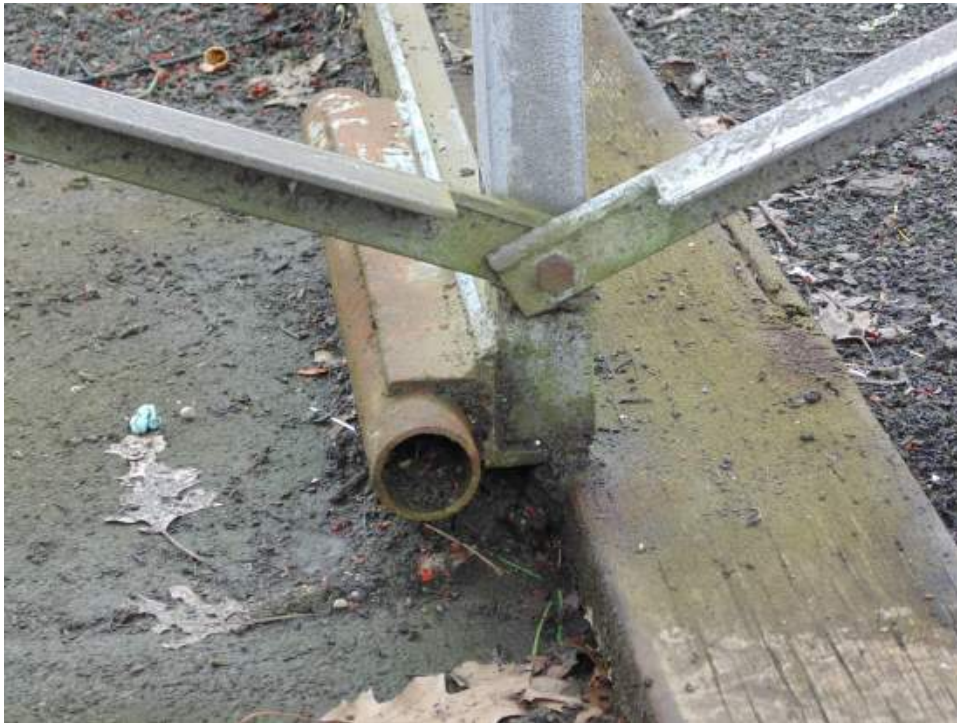
FIGURE W2: BASE ANGLE HANGING OFF SUPPROTING WOOD

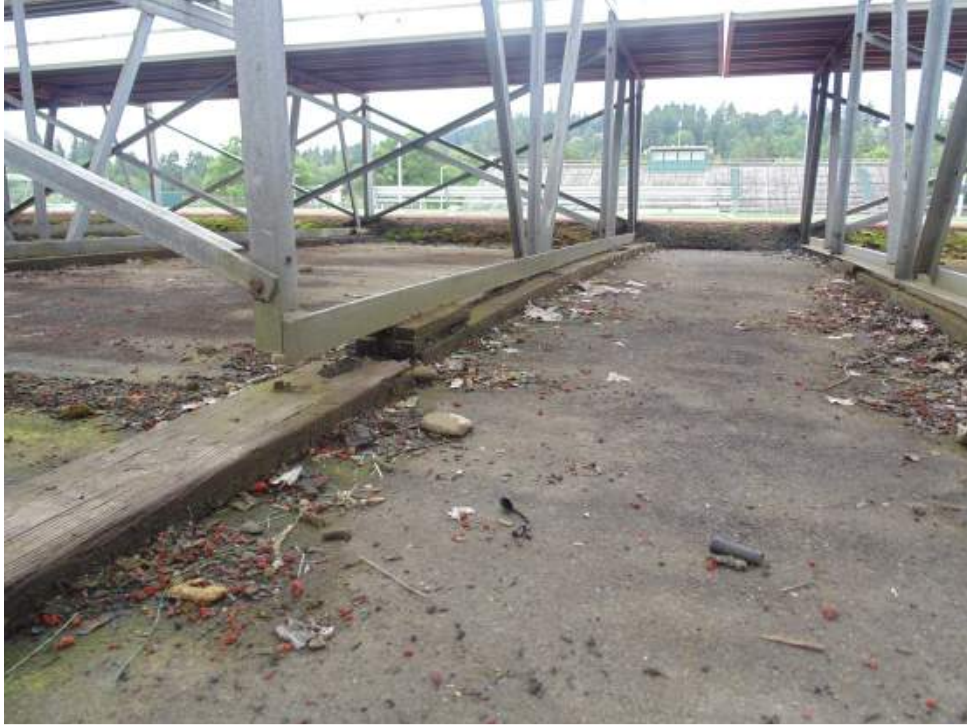
FIGURE W3: BASE ANGLE FLOATING AT POINT OF SUPPORT
